Turtle Beach PX22 Microphone Replacement

A non-responsive microphone may need to be replaced.

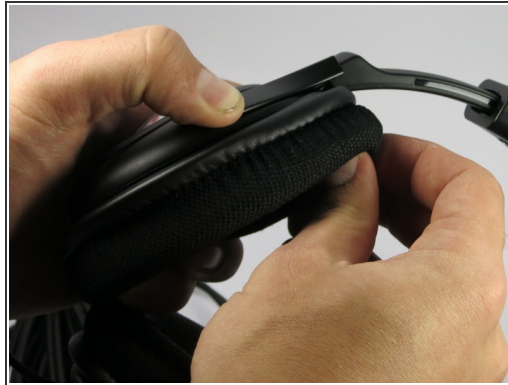
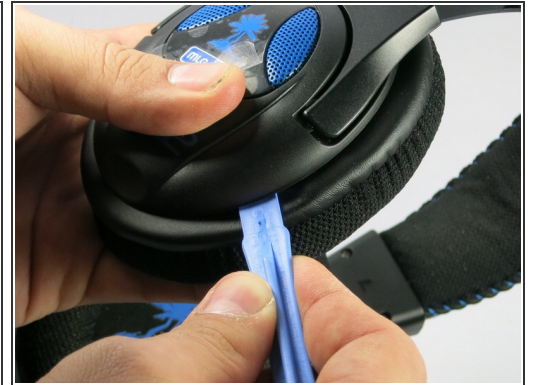
Step 4

- Position the speaker on the headset so that the screw holes line up. It should click into place.
- Screw in the 3 screws with the 00 Philips head screwdriver.
- Place the new cushion against speaker and wrap the leather around the plastic. Do this by working around the cushion to get all of the leather around the plastic.
- Use the plastic opening tool to tuck excess leather inside the headset.
